Topic: ALKY-ONE Corrosion Sealability Test

Rev. Date: 8/20/2013

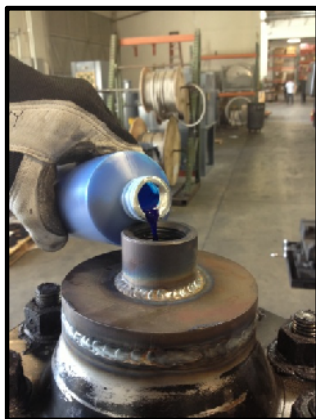
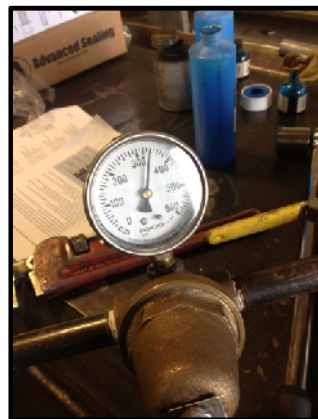
Once assembled, the test fixture was charged with blue ink and pressurized to 350-psi to simulate the upper limits of process operating pressure. (Figures 4 and 5) Of primary interest was the distance the ink penetrated between the chamfered flanges and the gasket.

Following the test, the test rig was thoroughly dried and carefully disassembled. Photographs of the components and gaskets were taken, as were measurements of the ink-ring diameters, showing the distance up the chamfered flanges that the ink had been able to penetrate. Because the chamfer's slope was known, we were able to determine the depth of the flange irregularity against which the gasket could seal.
